# Brodhead Road

## Corridor Planning Study

Existing Conditions and Issues

April 2021 (DRAFT)

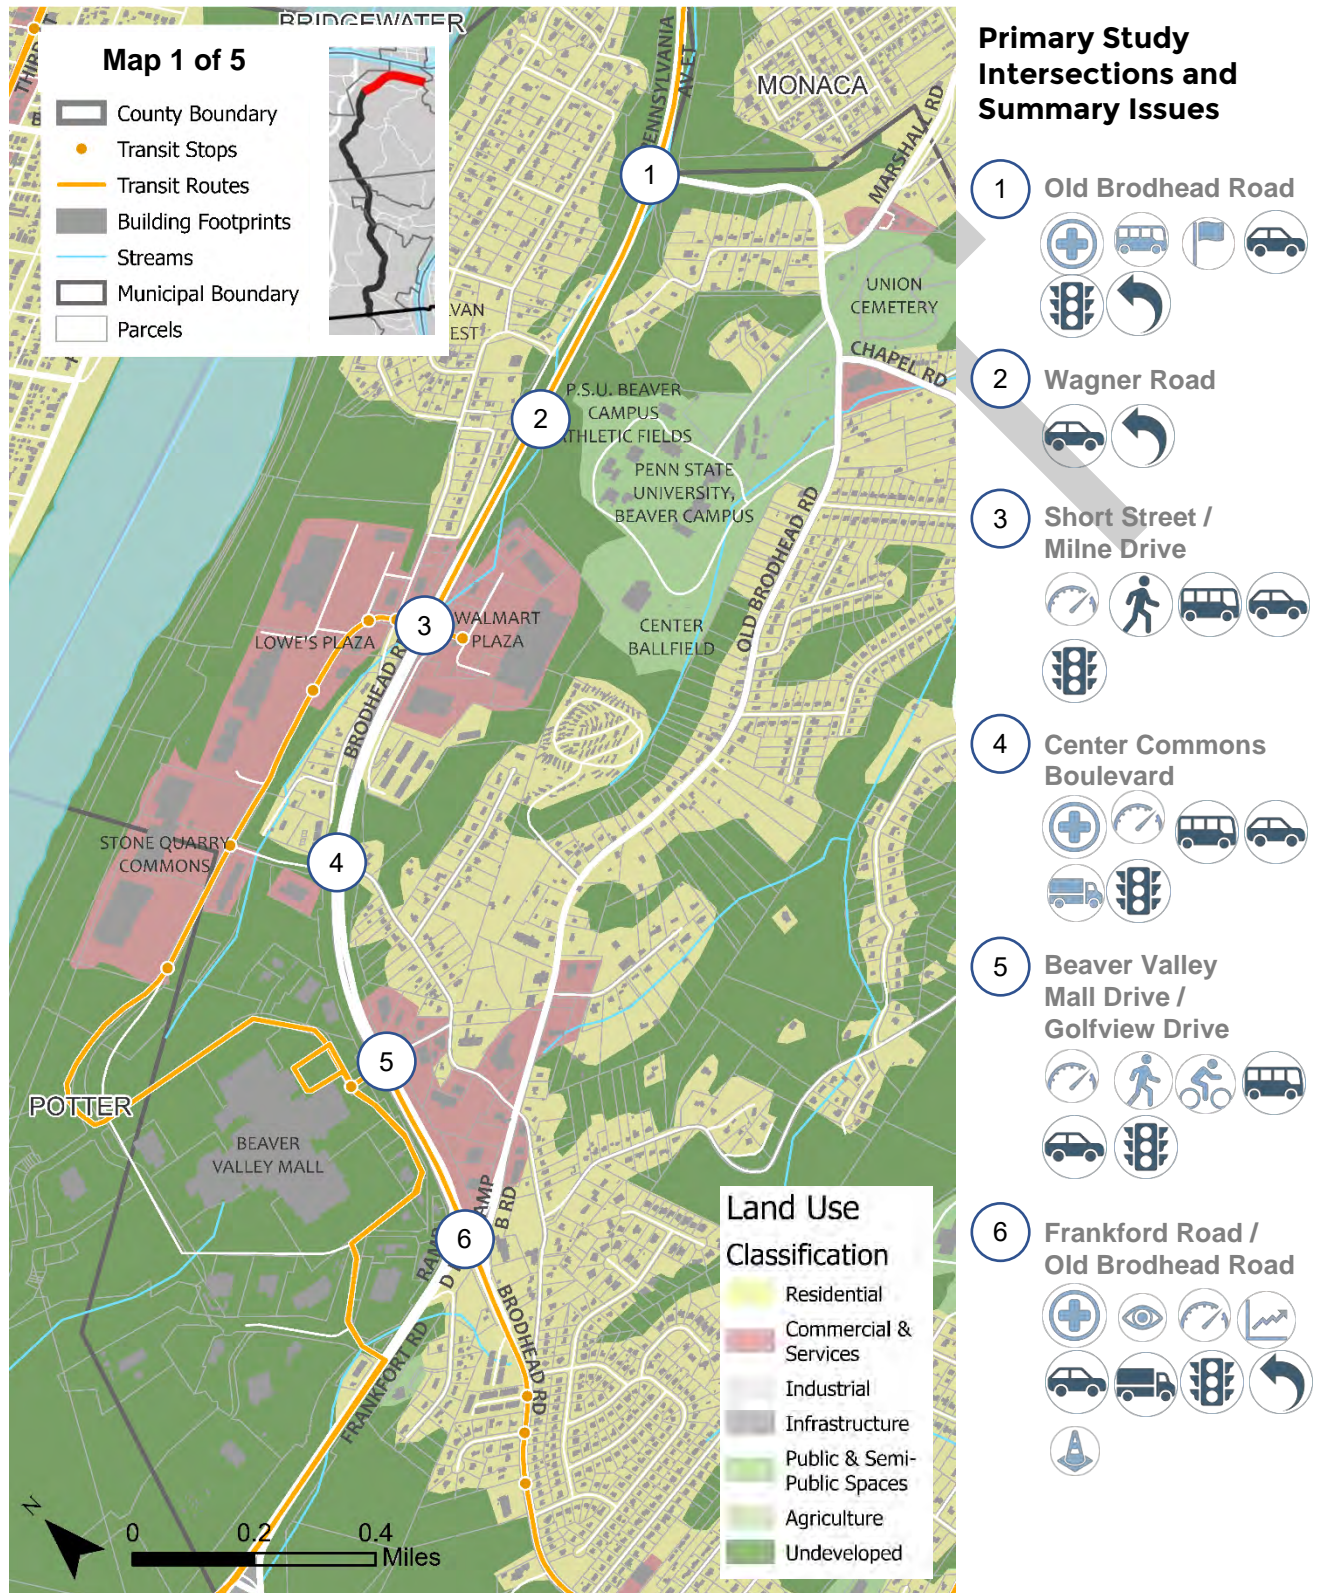
Exhibit 4: Existing Conditions Summary (Map 1 of 5)

- **Operations** – Minor upgrades to traffic signal detection and lane usage may be beneficial. Traffic signal observations noted that the side-street detection may activate prematurely, and that side-street right-turns periodically use the limited shoulder to squeeze past vehicles waiting to turn left.

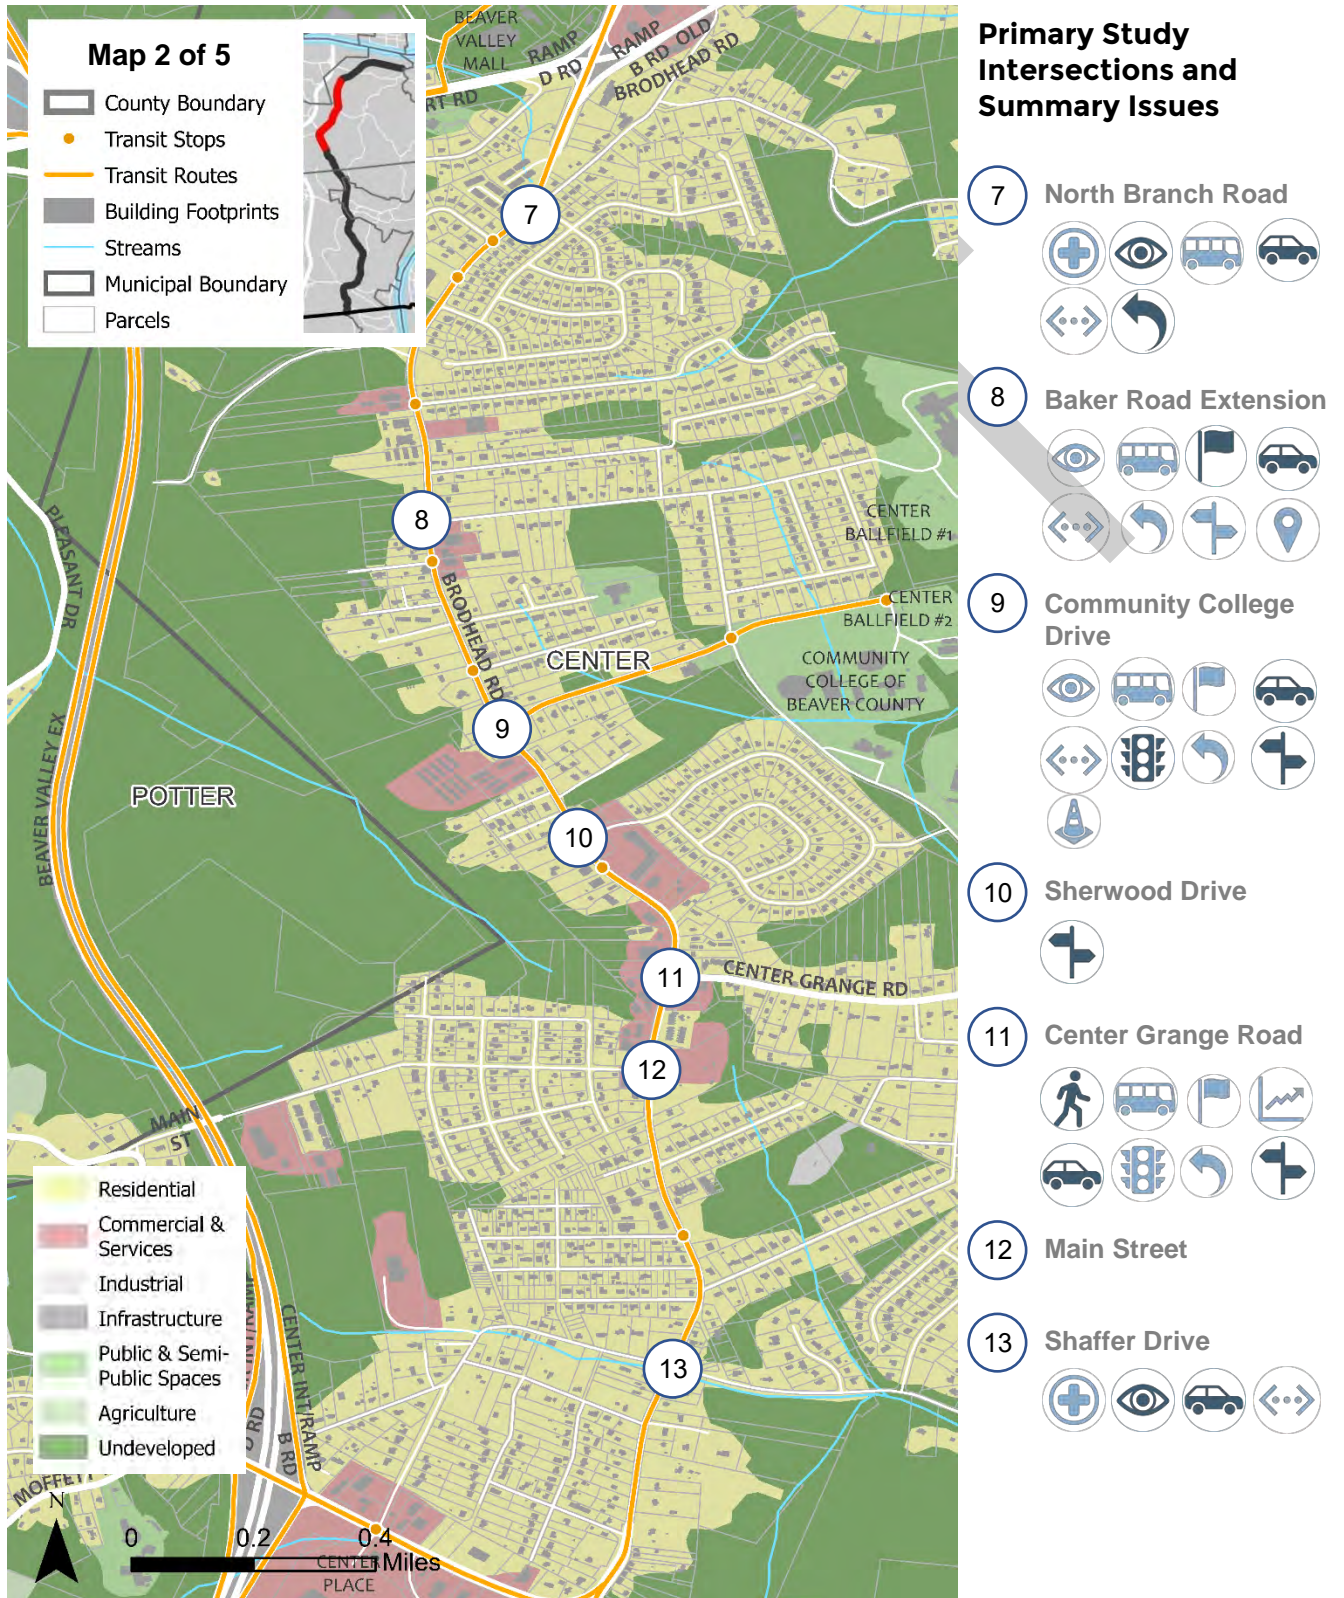
Exhibit 5: Existing Conditions Summary (Map 2 of 5)

INT # 7								
North Branch Road								
INT # 8								
Baker Road Extension

The pair of intersections for **North Branch Road at Brodhead Road** and **Baker Road Extension at Brodhead Road** are typical of unsignalized intersections along the corridor that operate with stop-control only on the side-street approaches and experience access difficulties given the demands they carry to make key connections to/from the mainline corridor.

- Accessibility** – Baker Road provides a direct connection to Central Valley High School, and anecdotal comments have noted that school traffic through the area heavily impacts not just Baker Road, but also spills one block north to Christy Drive. Both locations can be difficult for car or bus access to/from Brodhead Road. Pedestrian and bicycle activity have been noted to use North Branch Road. BCTA has also generally noted that transit stops on this stretch of Brodhead Road can be difficult with no pullover areas and with aggressive drivers periodically passing stopped buses.

- Mobility** – Both routes have been noted as potential cut-through routes, including usage of North Branch Road to access Old Brodhead Road, and Baker Road school traffic that spills over onto Christy Drive. While both intersections operate acceptably at LOS C during the AM peak hour, they both operate at failing LOS E/F during the PM peak hour, and access onto Brodhead Road can be difficult.

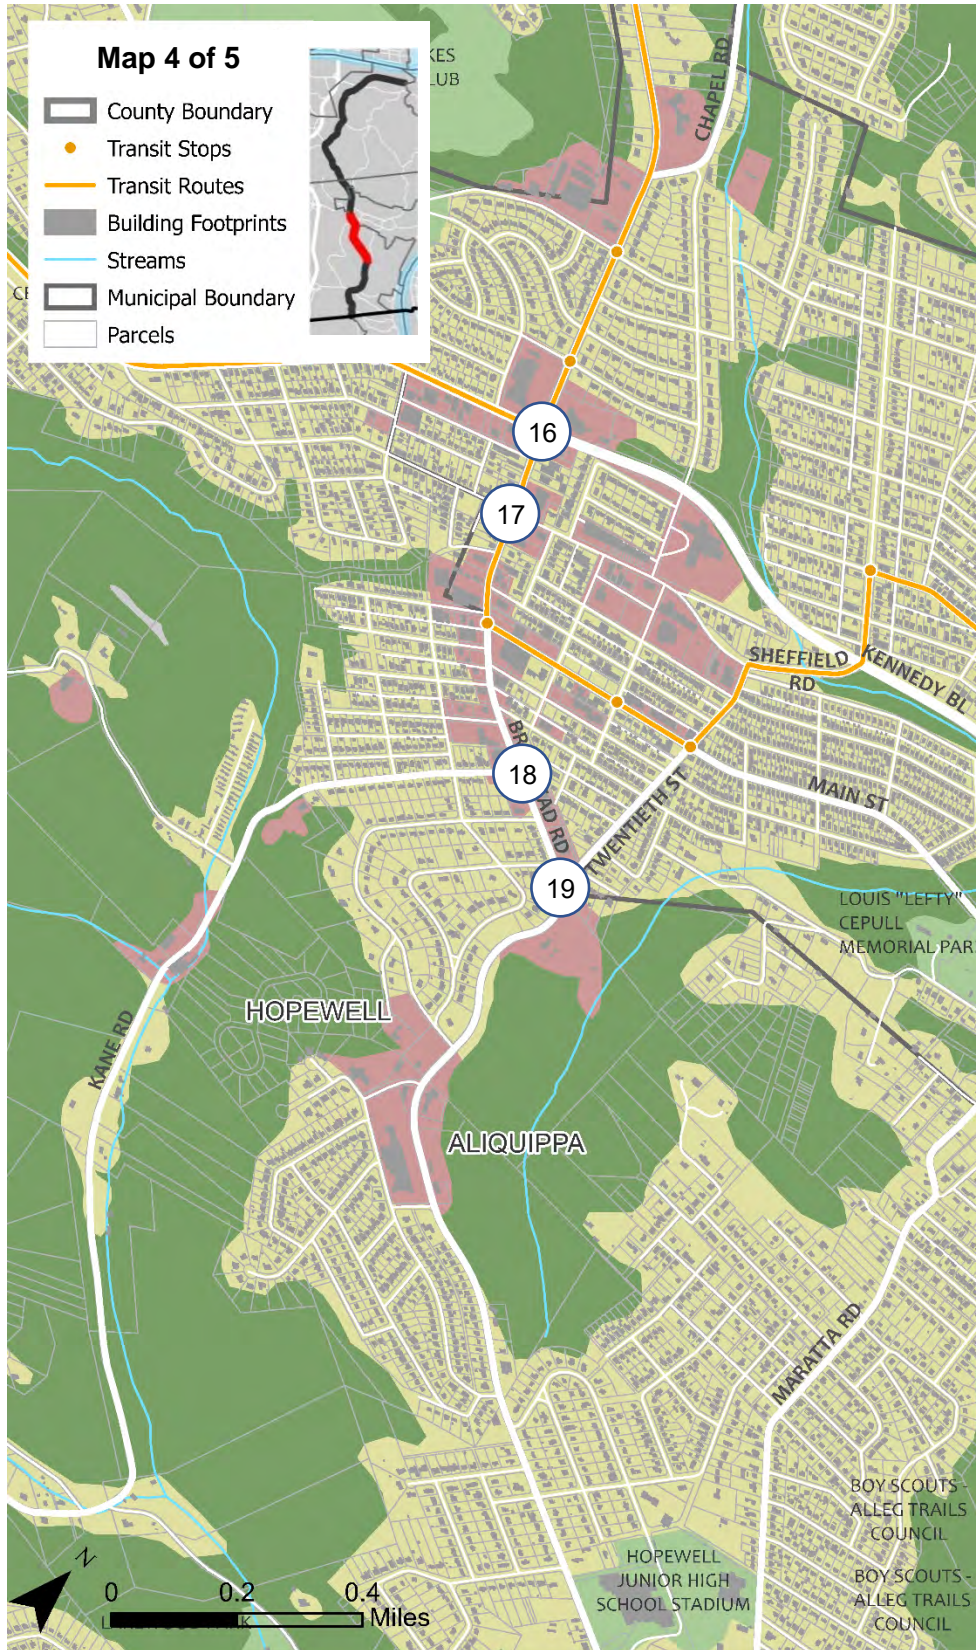
Exhibit 7: Existing Conditions Summary (Map 4 of 5)

**Primary Study Intersections and Summary Issues**

- 16** Mill Street / Kennedy Boulevard

- **Mobility** – Morning/afternoon congestion can be significant with existing LOS D/F and several failing movements or approaches in either peak.
- **Operations** – Delays and queuing on Brodhead Road are exacerbated by numerous driveways and parking access issues, upstream congestion spillback from Mill Street/Kennedy Boulevard, and turning delays/blockages with no space for turn lanes at the intersection today.

- **Planning and Infrastructure** – The narrow location and driveway/right-of-way constraints create a challenging environment for considering better pedestrian, transit stop, or turn lane infrastructure.

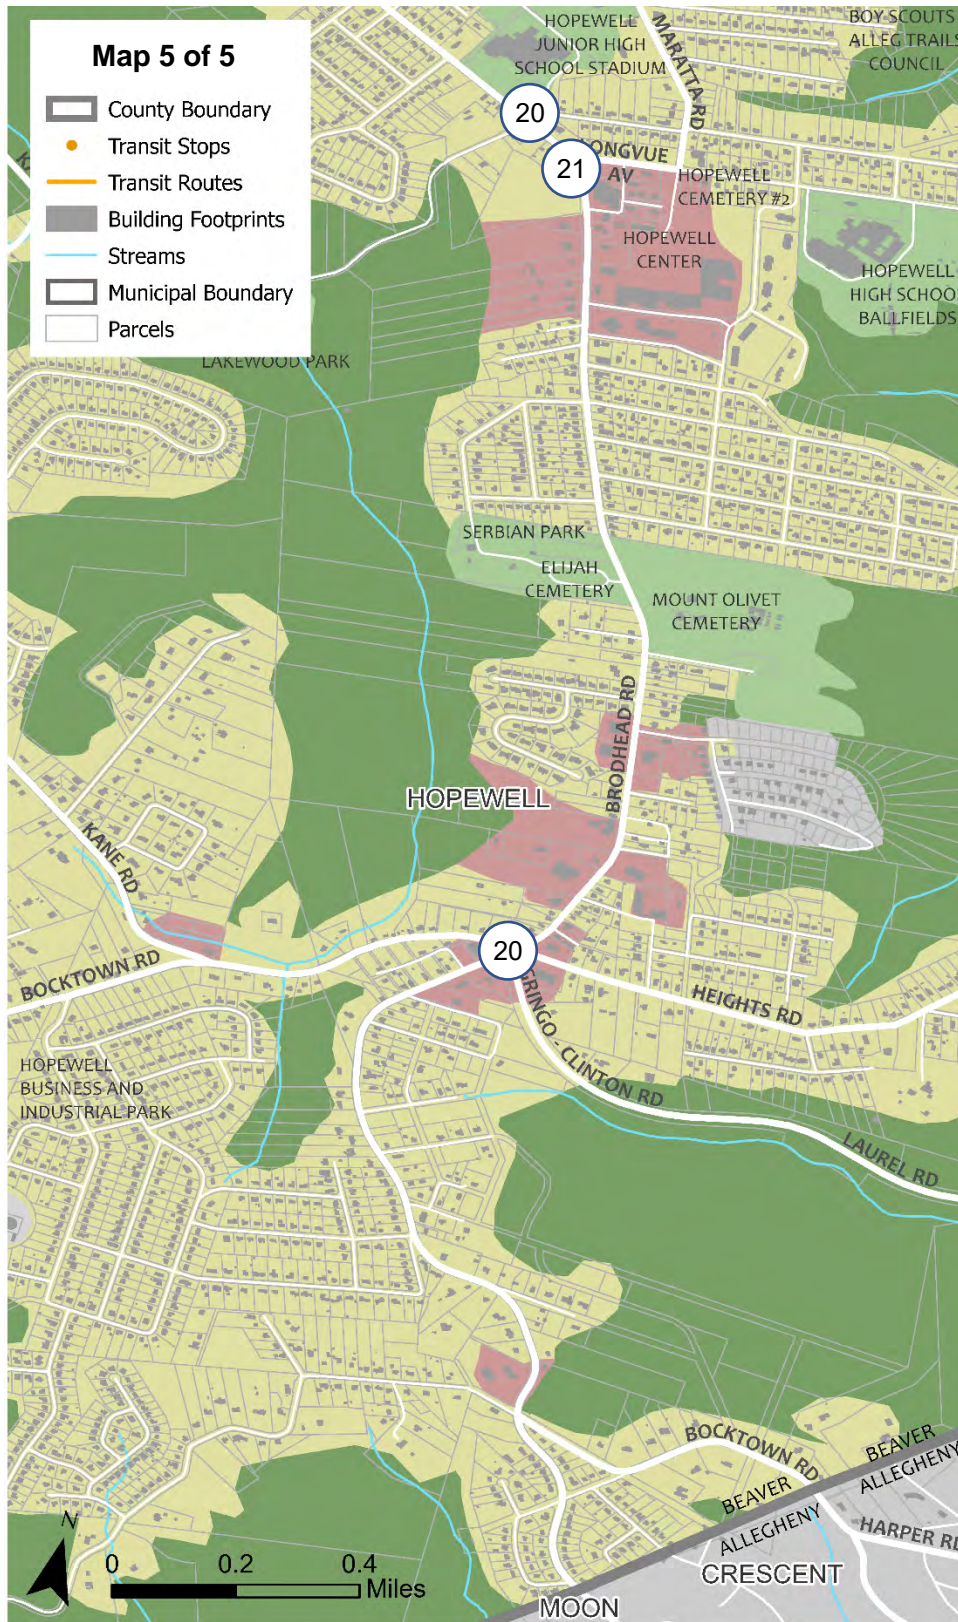
Exhibit 8: Existing Conditions Summary (Map 5 of 5)

INT # 20								
Laird Avenue

INT # 21								
Longvue Avenue

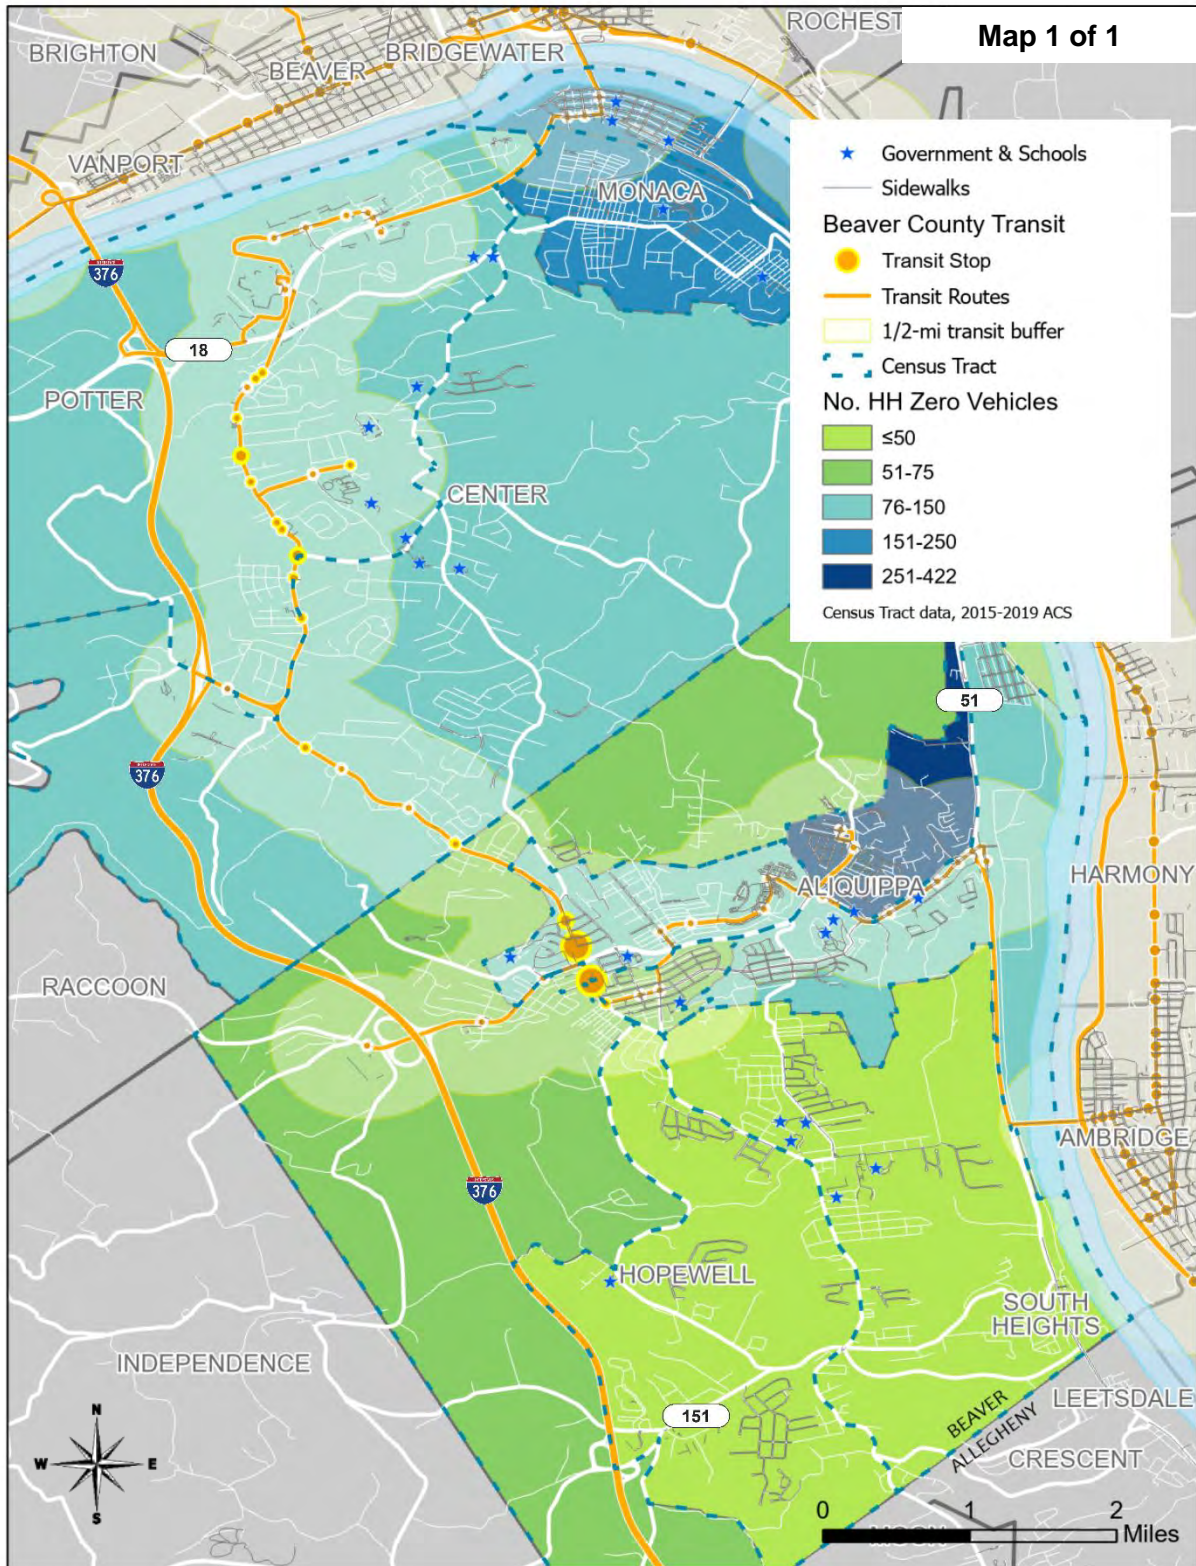
Exhibit 9: Vehicle Access and Walkability

- Another indicator of likely pedestrian activity and bicycle and transit use is Census data showing where a high percentage of households have zero vehicles. The Census tracts showing the highest rates of households with zero vehicles are those in Aliquippa, which also experience high poverty rates, as noted above. Tracts in Monaca show similarly high rates of households with zero vehicles; these tracts lie immediately outside the northern end of the corridor study. People living in these Census tracts are likely to walk, cycle or bus to destinations, at least some of the time. See the map on the following page.

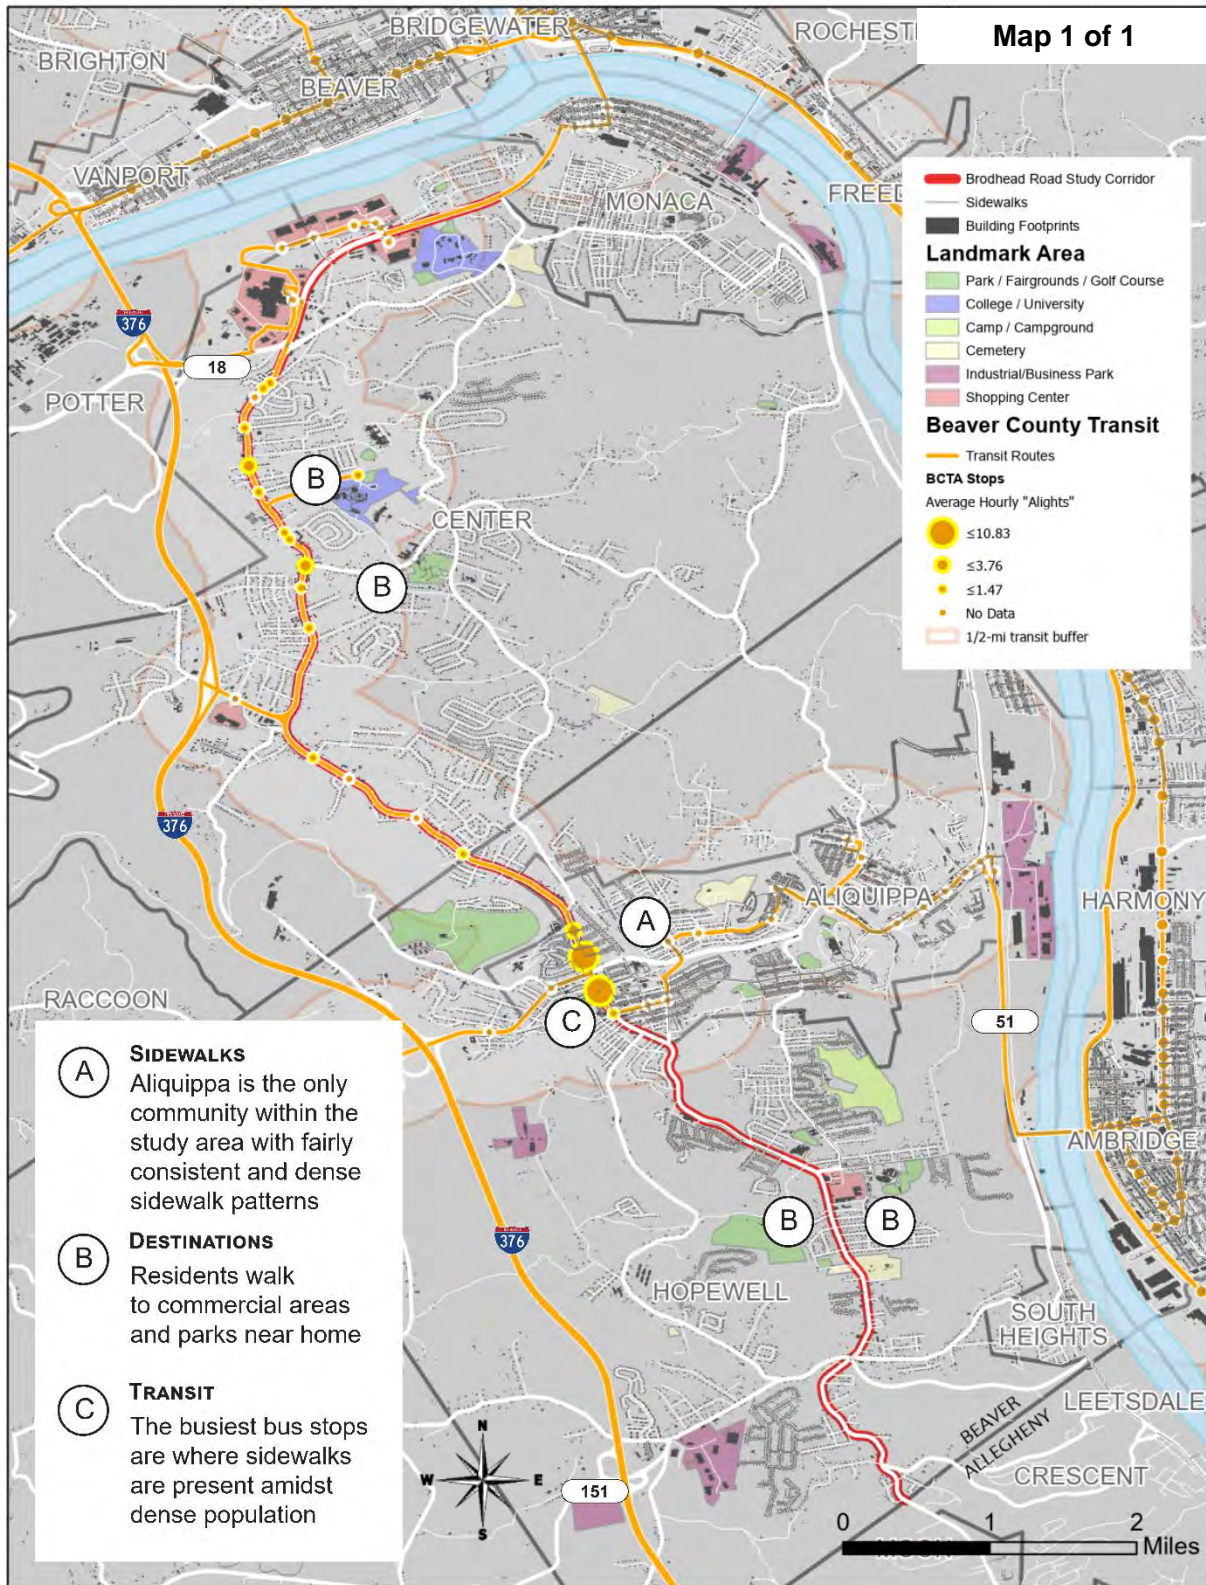
Exhibit 10: Pedestrian Activity

Sidewalks fronting the roadway are rare along Brodhead Road in the study area, with documentation showing very few intermittent segments totaling 0.01 linear mile in Center Township, 0.45 linear mile in Aliquippa, and 0.15 linear mile in Hopewell Township.

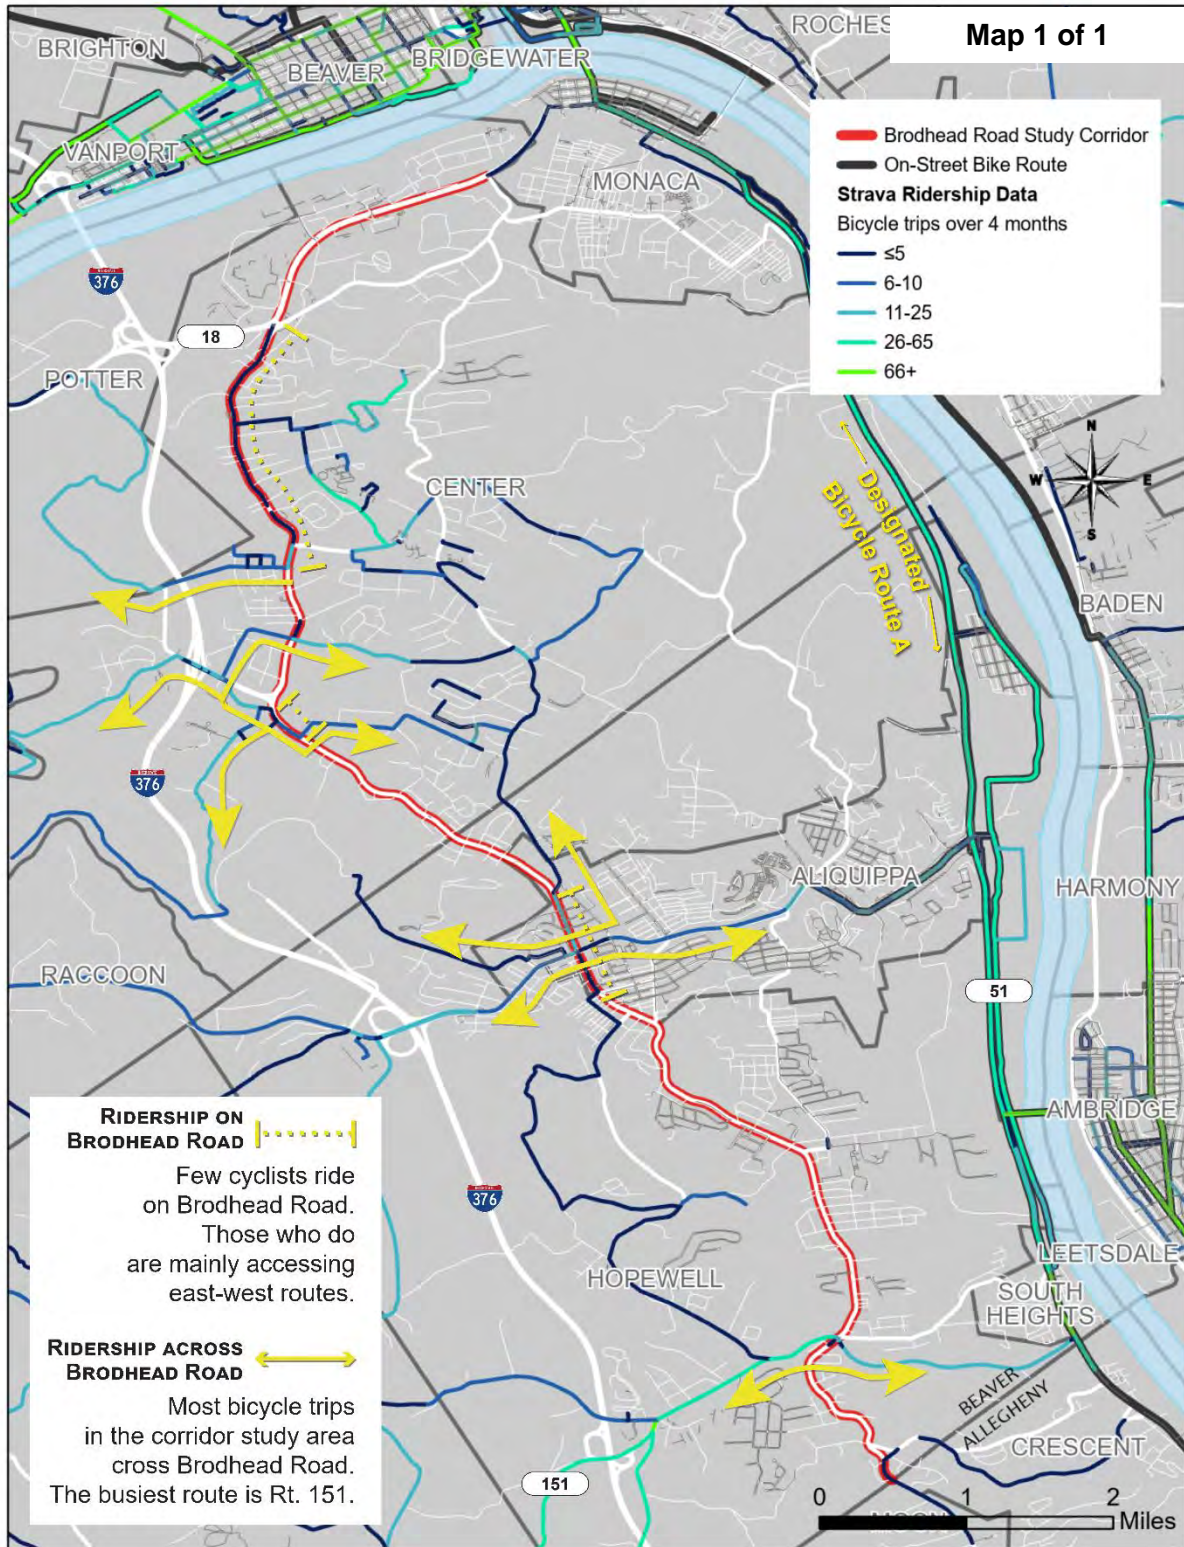
Exhibit 11: Bicycle Activity

Though the study area includes no bicycle infrastructure, cyclists are present in the corridor, mainly traveling across Brodhead Road, with only short-distance use of the roadway itself.

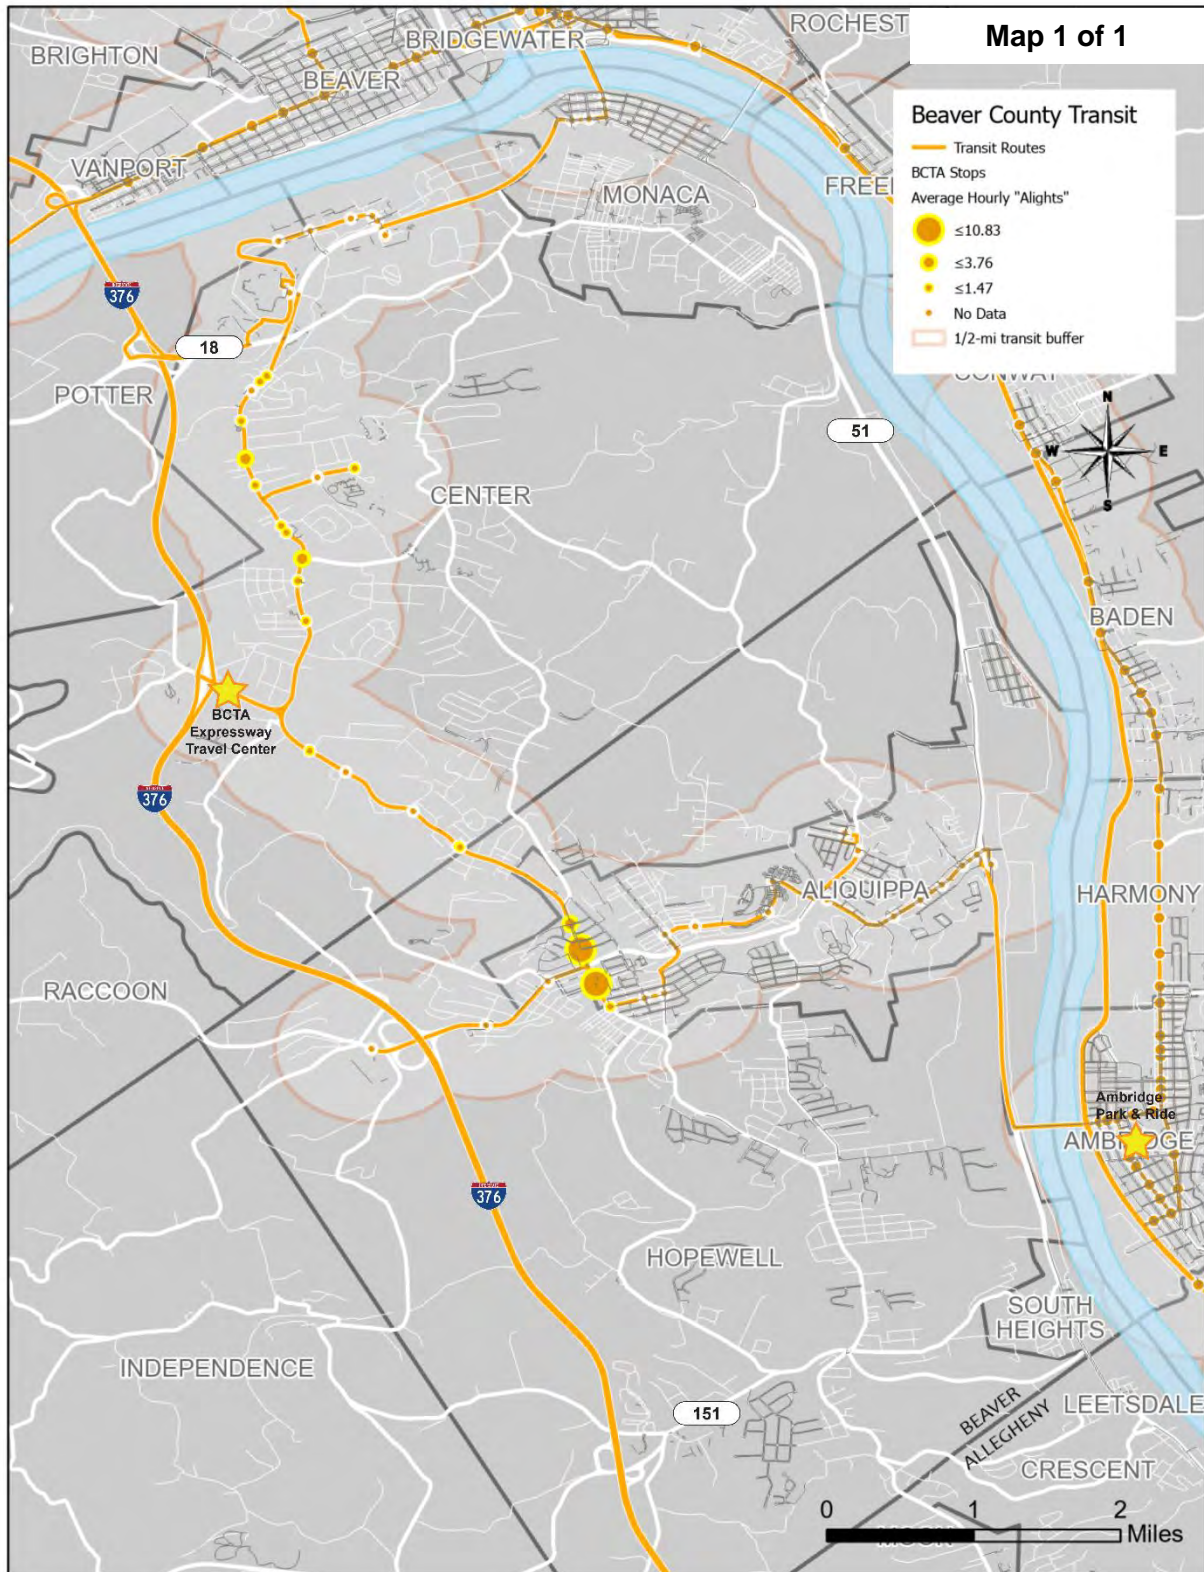
Exhibit 12: Transit Routes and Stops

BCTA Route 2 (inbound) follows Brodhead Road from Monaca. In Center Township, the route digresses from Brodhead to stop on Milne Drive (Walmart), and along Wagner Road (Township Marketplace, Beaver Valley Mall). Continuing south on Brodhead, the route digresses back-and-forth on Community College Drive to Community College of Beaver County and stops just off Brodhead at the Expressway Travel Center on Pleasant Drive.

Note: Ridership data reflects a point-in-time count in Spring 2021 and may differ from pre-Covid patterns.

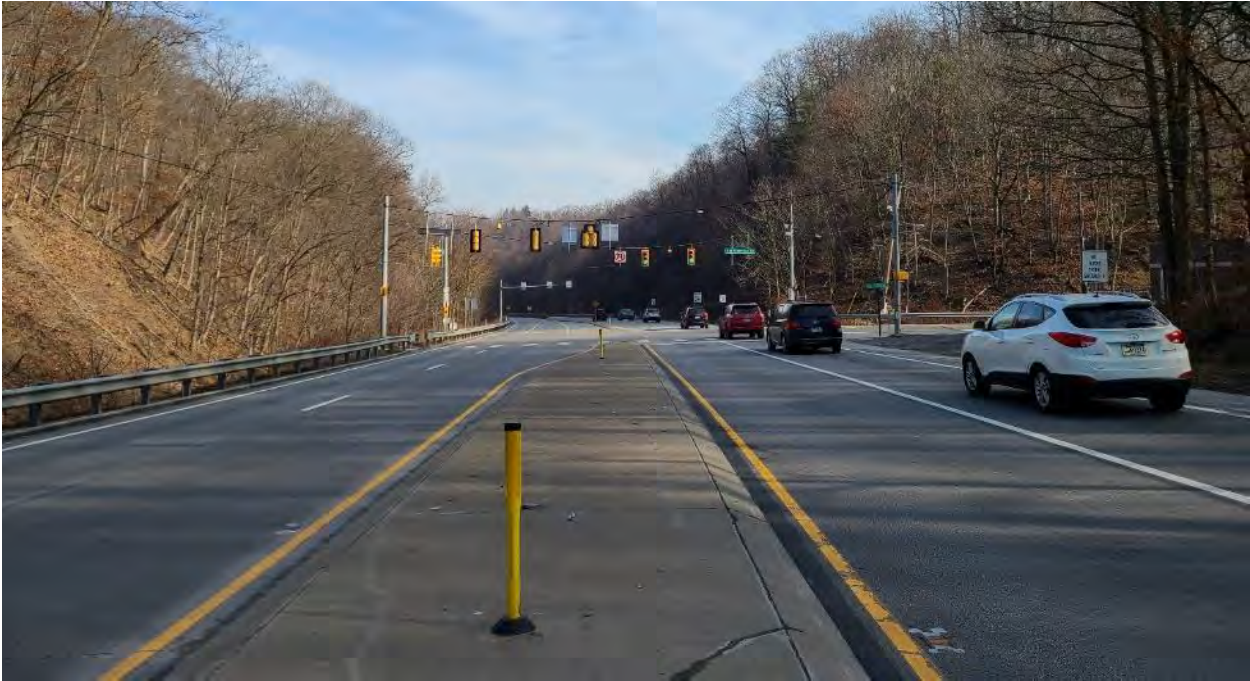
Exhibit 13: Typical Four-Lane Cross-Section

*Lane Widths:* Lane widths in the study area vary between 11 feet and 12 feet, and shoulder widths vary from less than 1 foot to 9 feet. Most of the roadway features paved shoulders dropping off to grass, though areas near major intersections and dense retail access have curb and gutter.

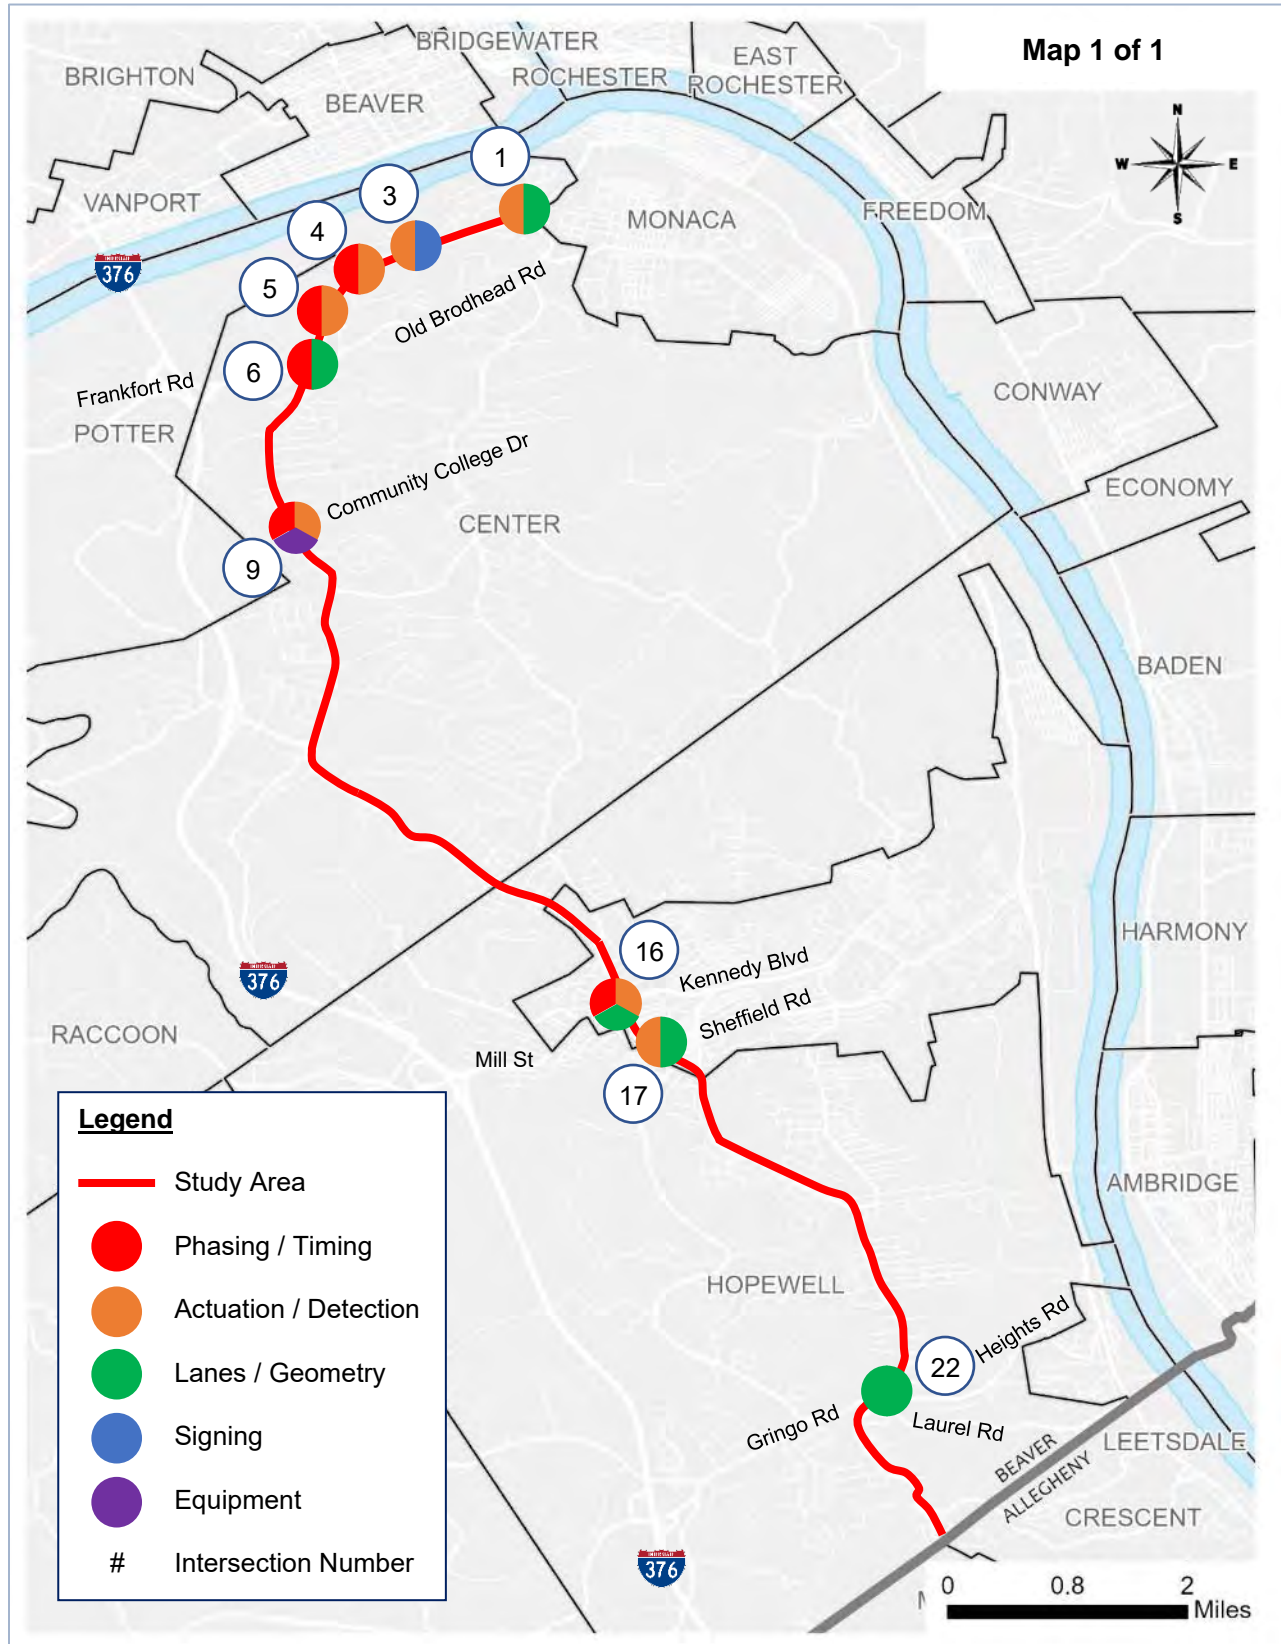
Exhibit 15: Potential Traffic Signal Needs

- *Phasing / Timing* – Adjust split lengths to decrease minor movement delay, review all-red clearance times, eliminate split phases
- *Actuation / Detection* – Adjust actuation to avoid unnecessary phase changes, investigate detection settings to decrease minor movement delay, review detector locations
- *Lanes / Geometry* – Add turn lanes, reconfigure overall intersection geometry (Five Points), widen lanes
- *Signing* – Enhance signage for right turning traffic to yield to oncoming vehicles, add larger turn restriction signage
- *Equipment* – Install modern pedestrian signal heads, update intersection lighting

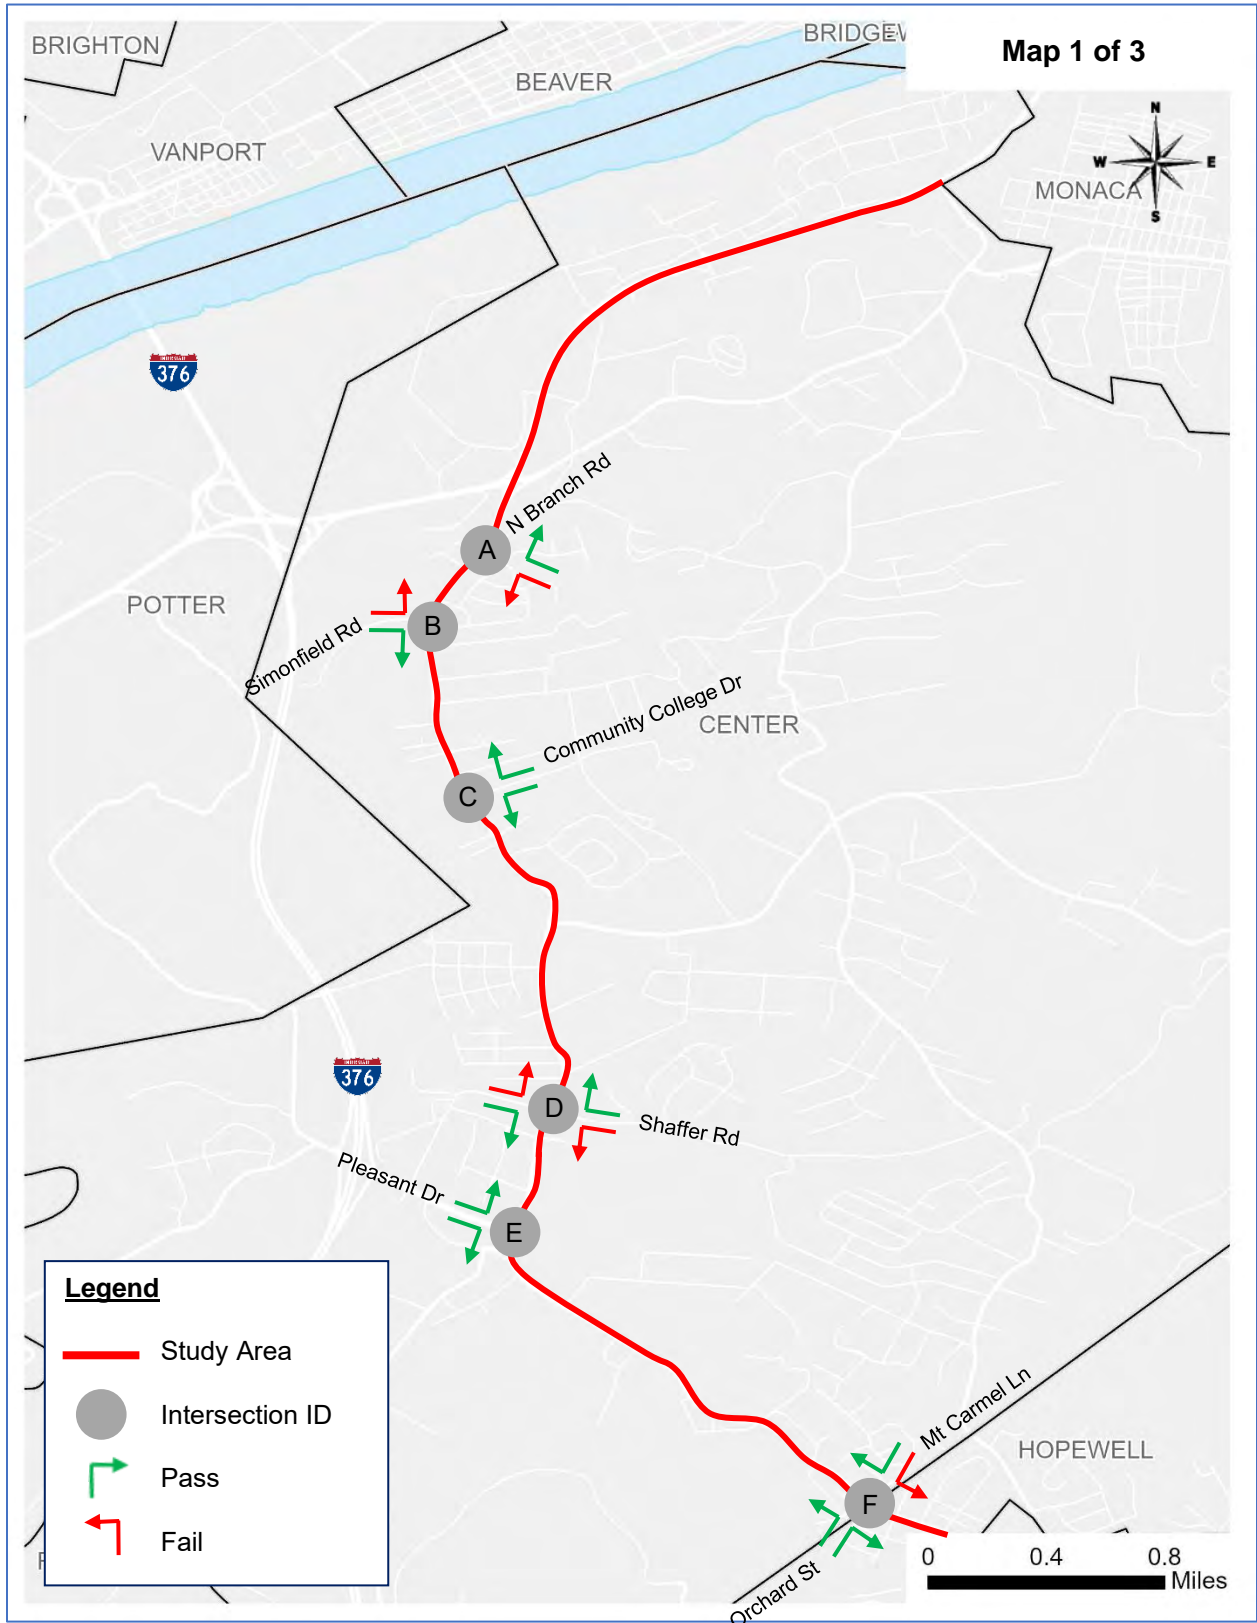
Exhibit 16: Potential Sight Distance Needs (Map 1 of 3)

Sight distance issues typically occur when drivers attempting to make a left-turn from Brodhead Road, or a left-turn or right-turn from any side-street, are unable to see the approaching or conflicting traffic a sufficient distance away to permit the driver to anticipate and avoid potential collisions. Possible sight distance obstructions can range from overgrown vegetation or the placement of roadside objects (e.g. signs, mailboxes, parked vehicles) to limitations caused directly by intersection geometry, approach grades, or the horizontal or vertical curvature of the roadway itself. Sight distance and related turning difficulties can also be more problematic in areas where travel speeds along the mainline corridor may exceed the posted speed limits – i.e. a distance that would be adequate to pull in front of traffic approaching at an expected speed of 35 MPH may not be sufficient if the approaching traffic is moving significantly faster.

- A N Branch Road (INT 7)
- B Simonfield Road
- C Community College Drive (INT 9)
- D Shaffer Road (INT 13)
- E Pleasant Drive (INT 14)
- F Mt Carmel Lane / Orchard Street
- G Chapel Road (INT 15)
- H 20<sup>th</sup> Street (INT 19) / Wigwam Road
- I Woodbine Road
- J Forge Road
- K Laird Avenue (INT 20)
- L Longvue Avenue (INT 21)
- M Cleveland Avenue
- N Harding Avenue
- O Miller Lane
- P Tee Line Drive
- Q Ohioview Avenue
- R Morrow Avenue / Yale Drive
- S Sharon Grange Road / Bocktown Road
