# Brodhead Road

## Corridor Planning Study

Existing Conditions and Issues

April 2021 (DRAFT)

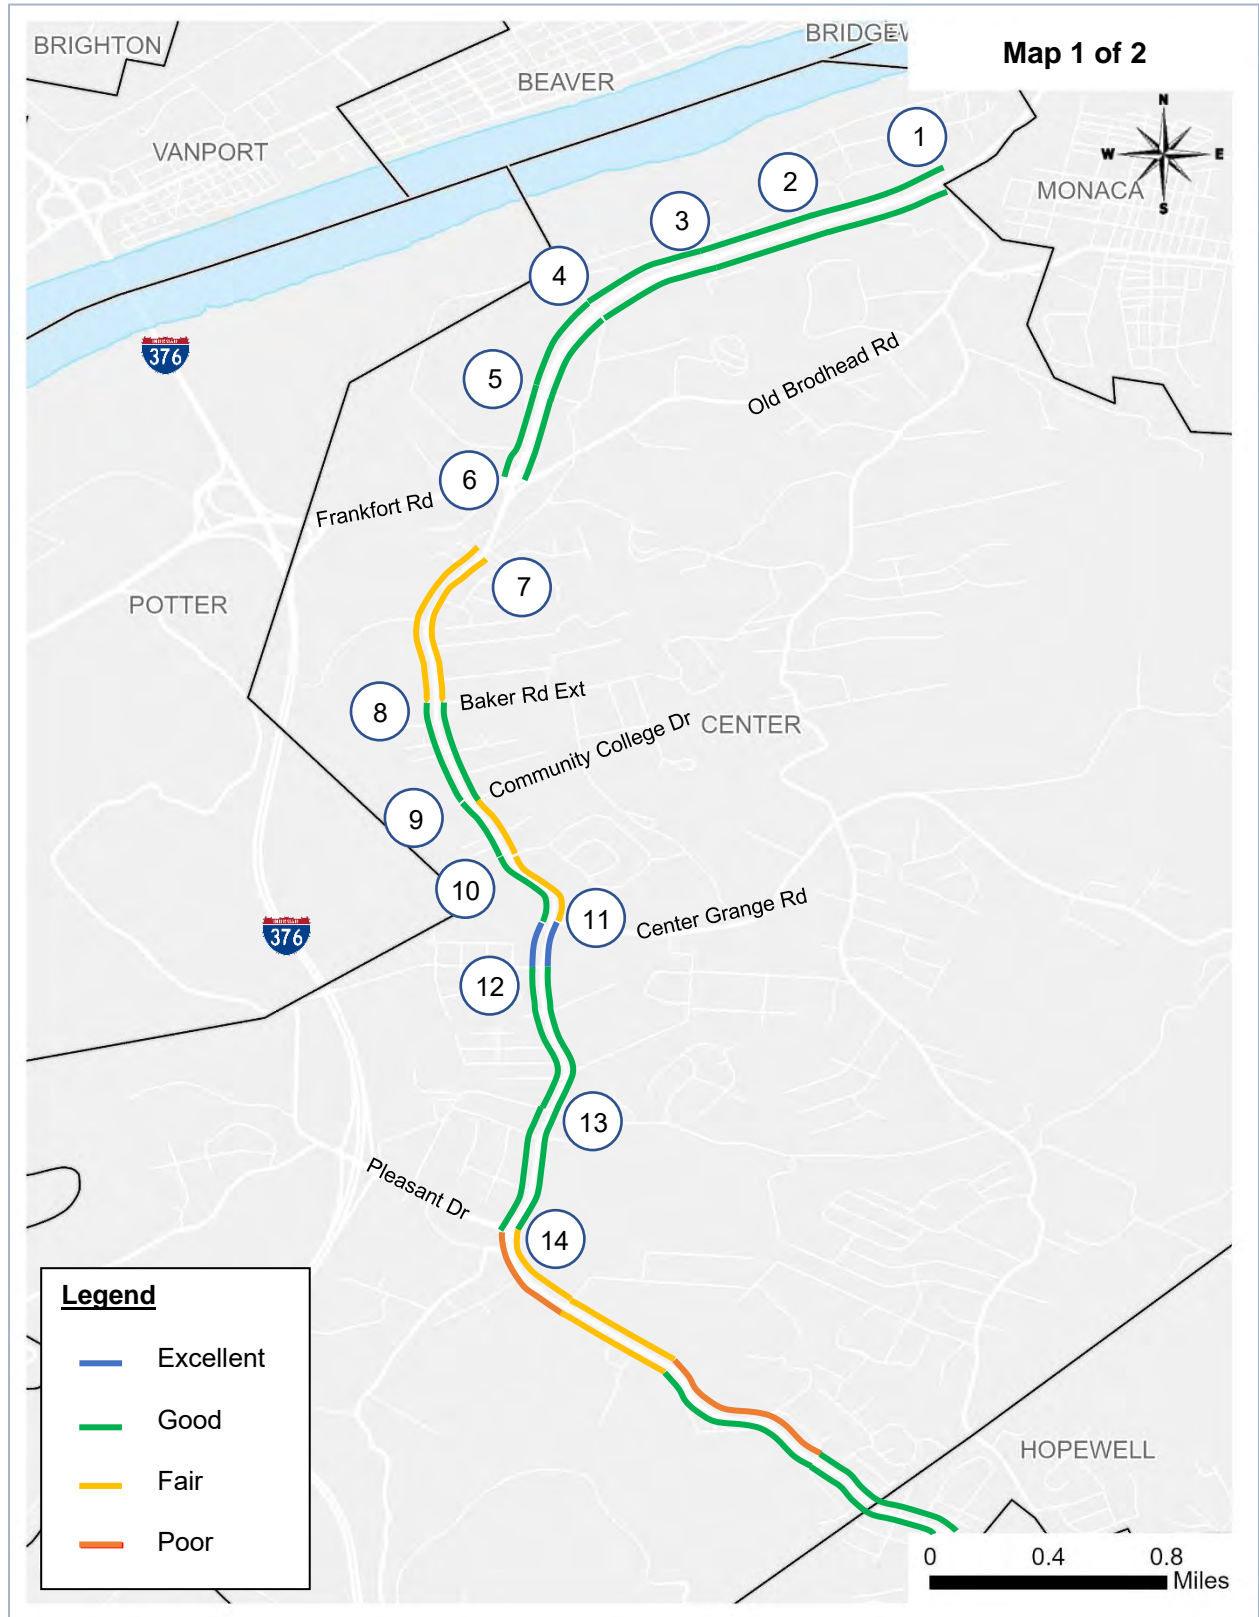
Exhibit 19: Nighttime Retro-Reflectivity Assessment (Map 1 of 2)

To help assess travel conditions and motorist guidance during hours of darkness, a nighttime field view and dashcam video was recorded to qualitatively assess the visibility, retro-reflectivity, or effectiveness of signs, pavement markings, delineation, and lighting throughout the study corridor. Specific nighttime observations focused on the following:

- *Lighting*
  - 44 of 56 segments (79%) were found to have dim or missing lighting
  - Improvements could explore new (or updated) LED technologies or additional luminaires
- *Markings*
  - 20 of 56 segments (36%) were found to have dim or missing pavement markings
  - Improvements could explore repainting the corridor with new materials, wider lines, or additional markings in critical areas
- *Delineation*
  - 2 of 56 segments (4%) were found to have dim or missing delineation
  - Improvements could explore installing new, replacement, or upgraded delineation
- *Signing*
  - 4 of 56 segments (7%) were found to have dim or missing signing
  - Improvements could install new or replacement signs, or explore other relevant options in critical areas such as larger signs, duplicate signs, reflective signpost panels, sign perimeter lighting, etc.

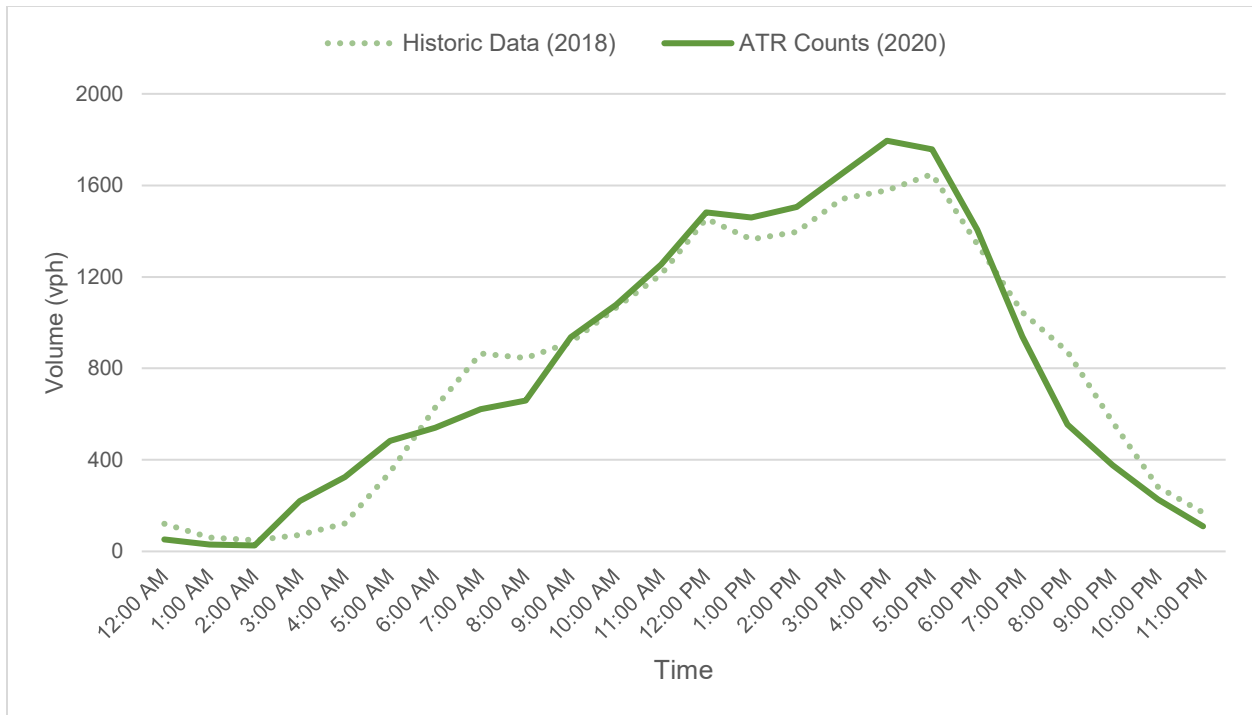
Exhibit 22: Hourly Volume Trends – North of Golfview Drive / Beaver Valley Mall Drive

A sample comparison of hourly traffic volumes throughout the day also indicates a unique pattern along Brodhead Road that varies from a traditional AM/PM commuter peak. Instead, both historic count data (from PennDOT’s online *Traffic Information Repository* (TIRe)) and the project-specific 2020 ATR count data show that traffic builds continuously throughout the day, beginning with the AM peak, continuing through a higher midday travel period, and reaching its highest level during the PM peak (*Exhibit 22* and *Exhibit 23*). This comparison also shows minor variations between the historic and current count data that may be explored to help support traffic volume adjustments to account for the influence of the COVID-19 pandemic as detailed later in this section.

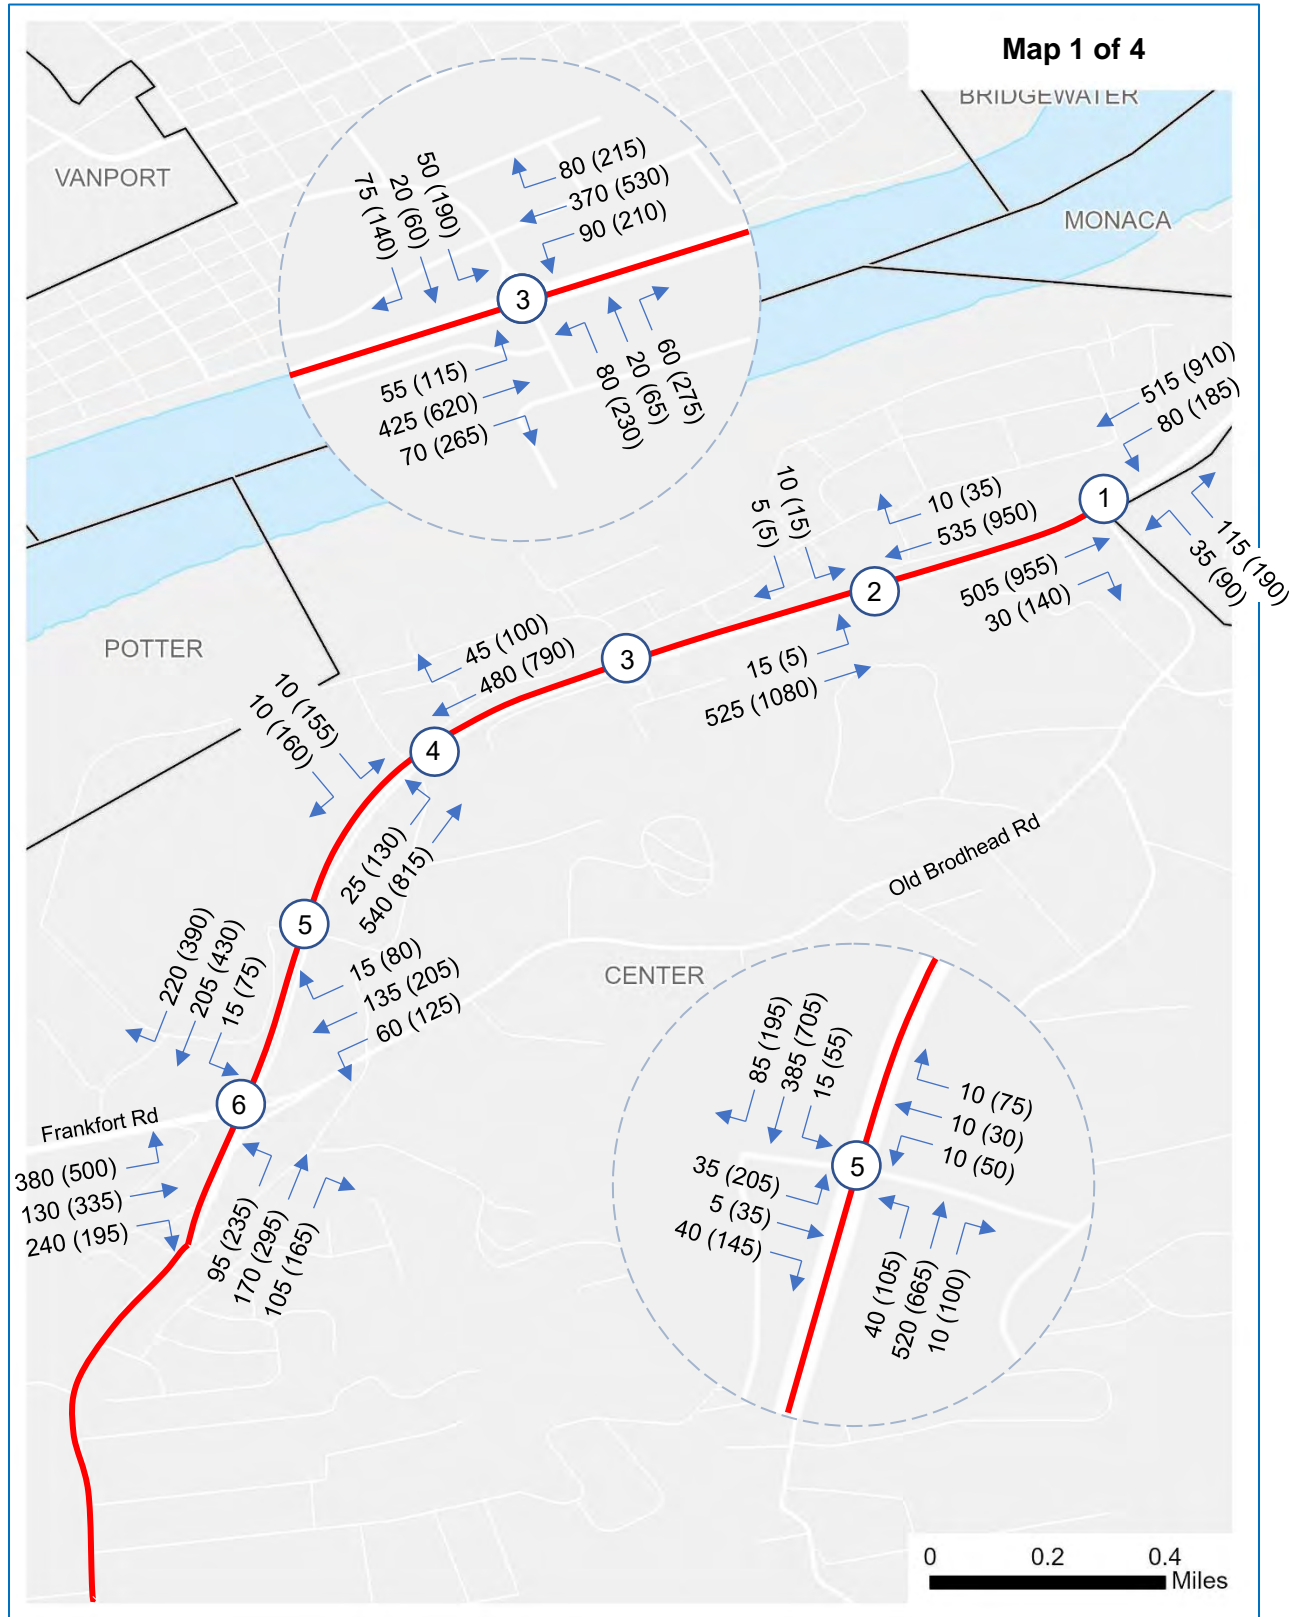
Exhibit 24: AM (PM) Peak Hour Volume Summary – 2020 Baseline Conditions (Map 1 of 4)

Turning movement counts (TMCs) were collected in January 2021 during a typical weekday (Tuesday or Thursday) at 22 study intersections using video based (Miovision) count equipment. The weekday TMCs covered a two-hour AM peak period from 7:00 AM to 9:00 AM, and a four-hour PM peak period from 3:00 PM to 7:00 PM. Count data included traffic volumes, pedestrian volumes, bicycle volumes, and percent trucks and buses at each intersection with details included in [Appendix A7 – Traffic Volumes](#). Based on this data, system-wide peak hours were identified as:

The final set of 2020 Baseline peak hour volumes are summarized in [Exhibit 24](#) through [Exhibit 27](#).

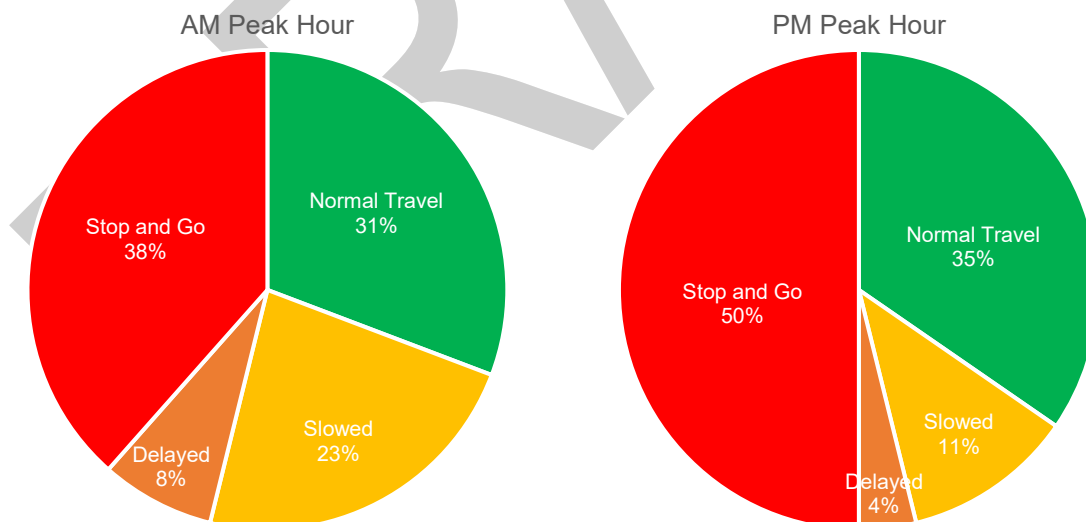
Exhibit 28: Travel Time/Condition Summary

Travel times and speeds along the study corridor were evaluated using SPC's access to INRIX data via the online *Regional Integrated Transportation Information System* (RITIS) platform ([www.ritis.org](http://www.ritis.org)). Available data were compiled for 13 INRIX segments along the corridor, averaged for one-year from January 1 through December 31, 2019. To estimate delay and congestion, the difference between the observed travel time and the no-stop travel time (derived from travel distance at the posted speed limit) was calculated for the northbound and southbound directions, and the AM and PM peak periods, to determine corridor-wide delay that could be expected on a typical weekday. Detailed speed, travel time, and delay estimates are included in *Appendix B2 – Travel Time and Speed Data*. Results indicate that end-to-end travel along the study corridor typically takes between 24-27 minutes, including 4-5 minutes of delay in the AM peak, and approximately 6 minutes of delay in the PM peak.

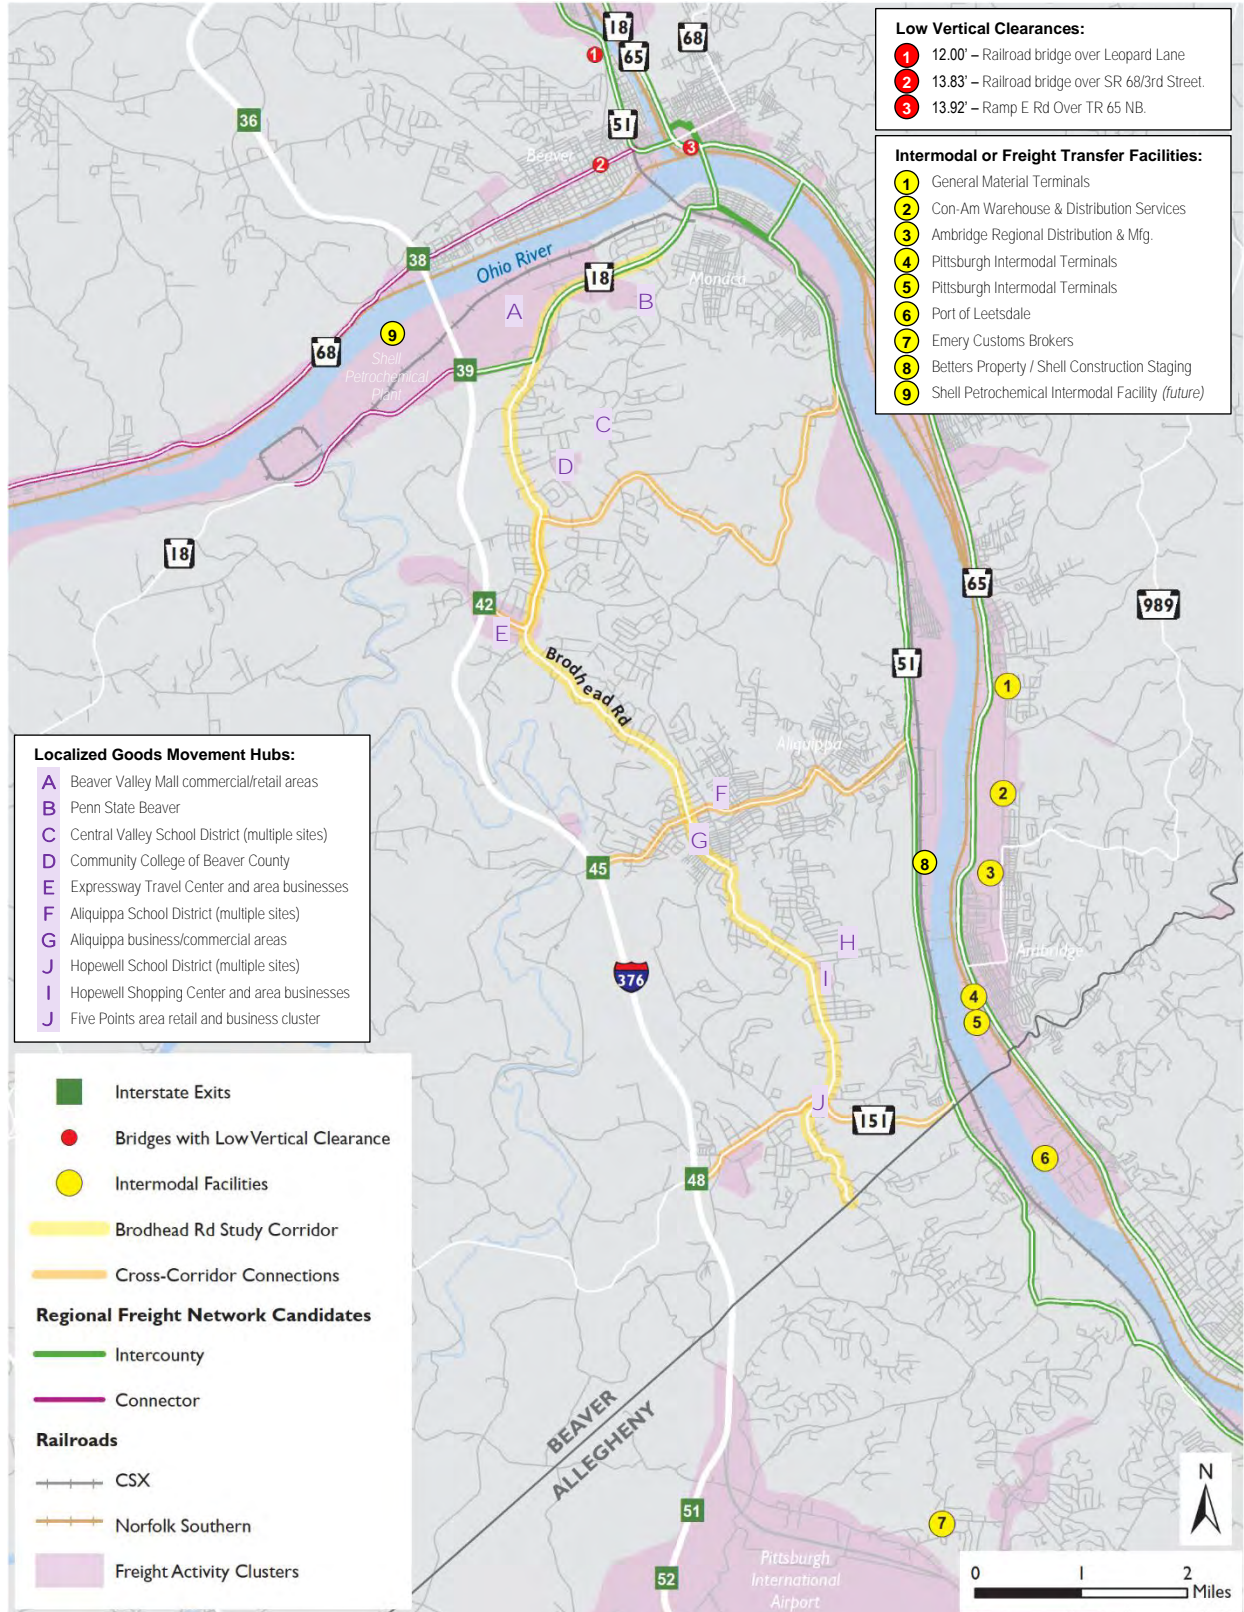
Exhibit 32: Freight Network Summary

*Localized Goods Movement:* Beyond the area’s broader freight connection perspectives, several important areas more local to the Brodhead Road corridor will also influence truck demands and goods movement activities that directly serve businesses and community assets throughout Center Township, Hopewell Township, and Aliquippa (*Exhibit 32*, Sites A-J). Such activities include the delivery of retail goods, food, supplies, equipment, gasoline, construction materials, or many other types of freight that keep the area’s businesses running, as well final-mile deliveries of packages and home goods throughout the area’s residential communities (e.g. Amazon, UPS, FedEx).

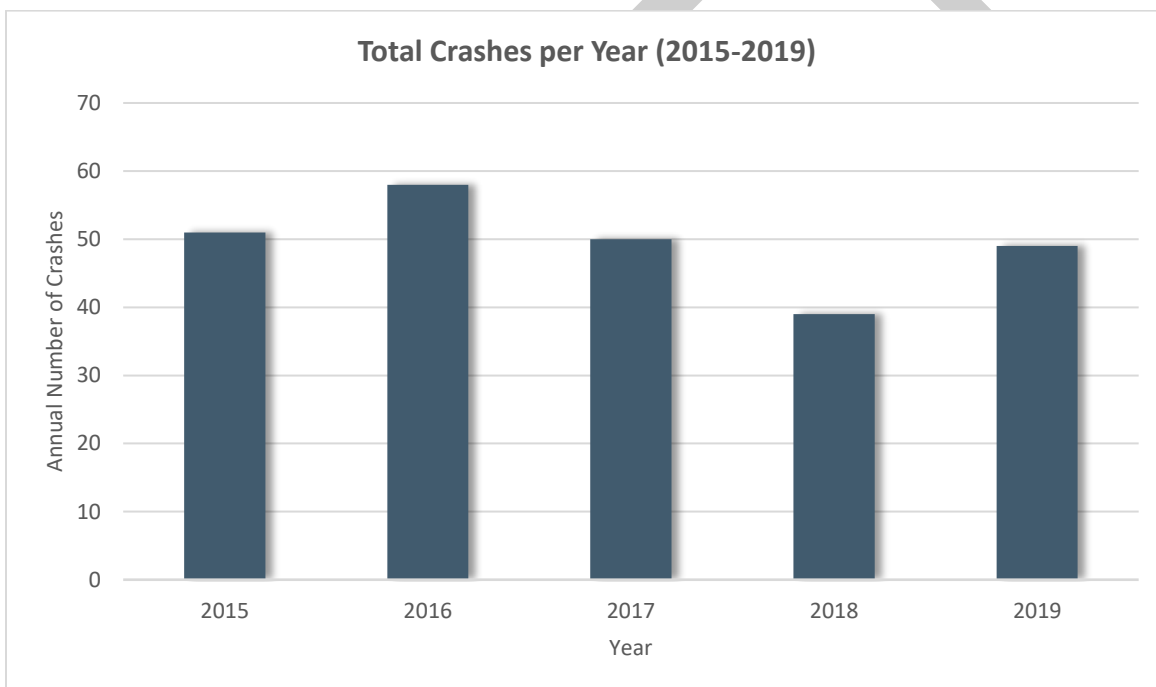
*Exhibit 33: Total Crashes by Year*

- The totals above do not include a potentially significant number of **non-reportable crashes** that also occur along the corridor. Non-reportable crashes typically reflect minor “fender-benders” with no injuries, no towed vehicles, and minimal property damage. Such occurrences may be recorded by local/municipal police but are not otherwise included in PennDOT’s PCIT database.
- No significant trends or anomalies were identified in terms of **crash location or time frame**; rather, higher levels of crash activity were logically observed at locations that experience higher volumes and during busier travel periods. Potential clusters, for example, were identified at the intersections of Brodhead Road and Frankfort Road / Old Brodhead Road, Mill Street / Kennedy Boulevard, and Five Points; and 37% of all crashes were found to occur during PM travel hours from 2:00-7:00 PM.

- No significant trends or anomalies were identified in terms of **crash severity**. Most crashes involved property damage only (52%), and the proportion of injuries or fatalities were all comparable to statewide averages. Only two fatalities occurred in the study area during the study period, with unrelated causes or locations.

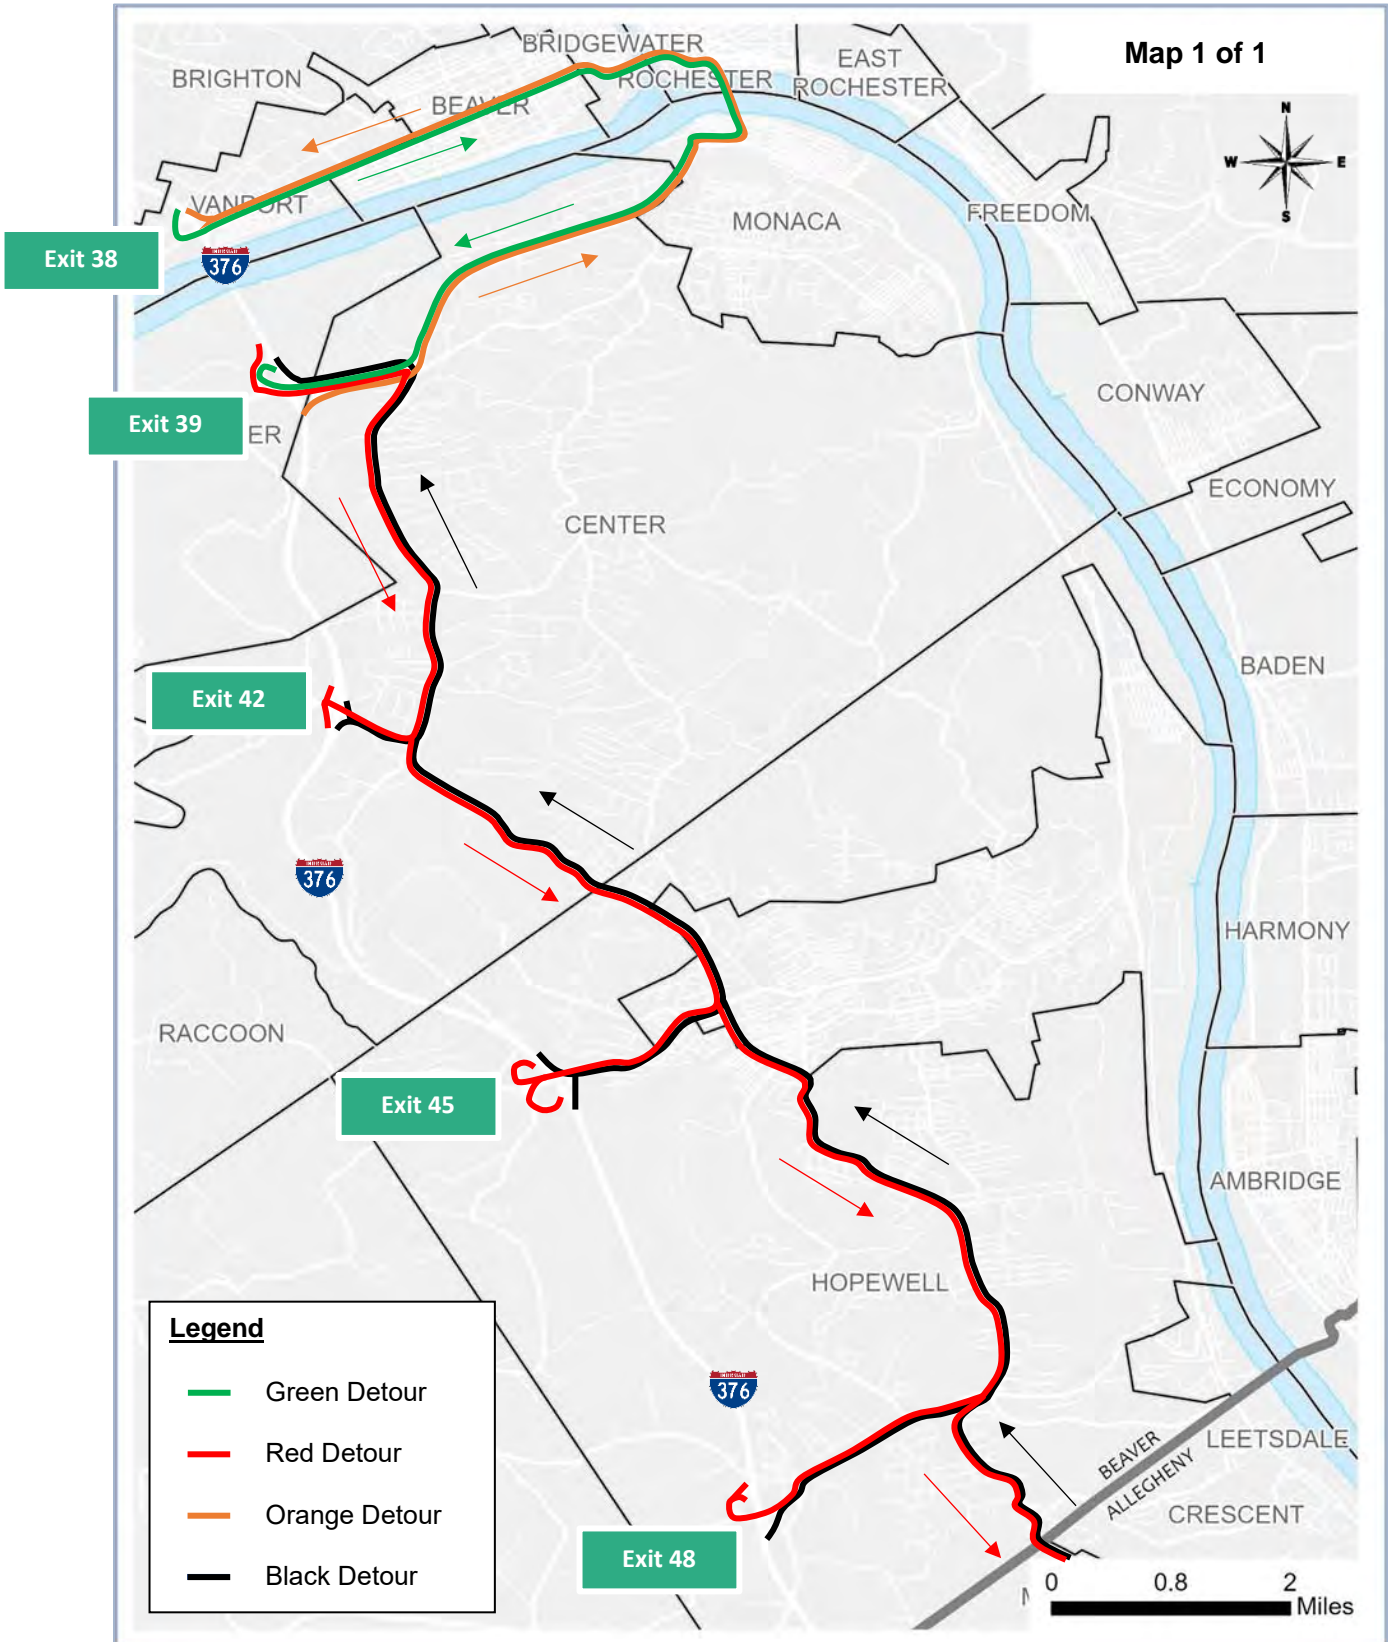
Exhibit 34: Interstate Emergency Detour Routes Influencing Brodhead Road

- **INT 6** Frankfort Road (SR 18) / Old Brodhead Road (to I-376 Exit 39)
- **INT 14** Pleasant Drive (to I-376 Exit 42)
- **INT 16** Mill Street / Kennedy Boulevard (to I-376 Exit 45)
- **INT 22** Five Points (to I-376 Exit 48)
